SUSQUEHANNA RIVER BASIN  
HARVEY'S RUN, CLINTON COUNTY.

PENNSYLVANIA  
UPPER CASTANEA RESERVOIR DAM.

(NDI I.D. No. PA-00393

PHASE I INSPECTION REPORT  
NATIONAL DAM INSPECTION PROGRAM

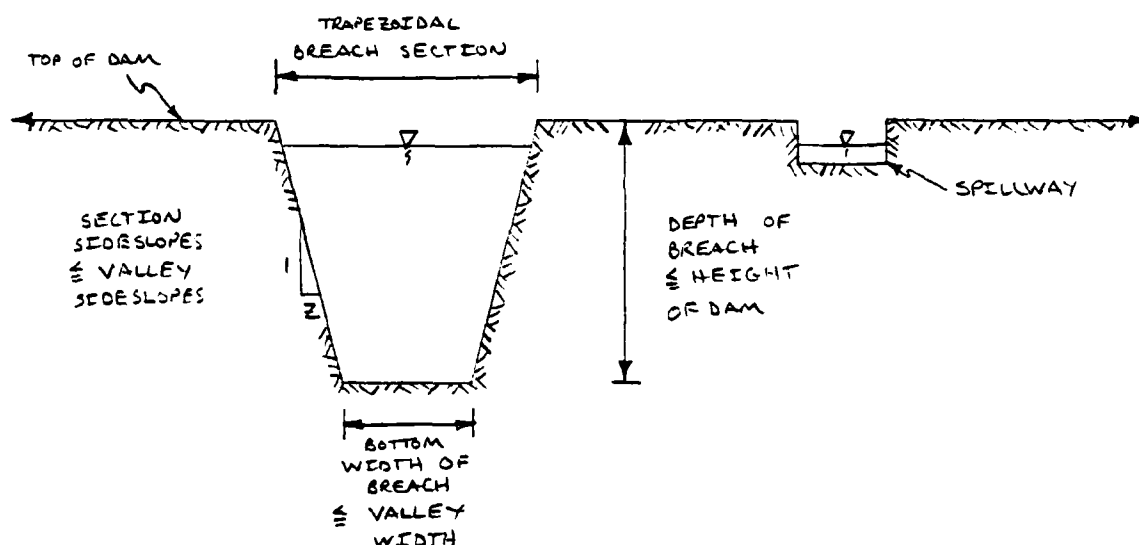
## BREACH ASSUMPTIONS

Two sets of breach geometry were evaluated for the Upper Castanea Reservoir Dam for each of two failure times (Appendix D, Sheet 18). The two breach sections chosen were considered to be the minimum and maximum probable failure sections. The two failure times (total time for each breach section to reach its final dimensions) under which the two breach sections were investigated were assumed to be a rapid time (0.5 hours) and a prolonged time (4.0 hours), so that a range of this most sensitive variable might be examined. In addition, an average set of breach conditions was analyzed, with a failure time of 1.0 hour.

The maximum section, in the case of the Upper Castanea Reservoir Dam, refers to the probable largest breach section through the thin portion of the dam. The embankment consists of a broad portion for a length of approximately 110 feet, and a thin portion for a length of approximately 110 feet (Appendix D, Sheet 19). It is assumed that the thin portion would fail before the broad portion, and thus, the broad portion would probably not contribute to the failure outflows. Also, since the dam has a concrete corewall, the possibility of an instantaneous or near-instantaneous embankment failure exists. However, time limitations within the Modified HEC-1 Computer Program prohibited the evaluation of such a failure.
